# RCI-52-23-001-1: Fascia, Front, Upper Repair

## Rivian Automotive, LLC Position Statement

| <b>Affected Model(s)</b> | R1T, R1S |
| <b>Vehicle System</b> | 52 - Body |

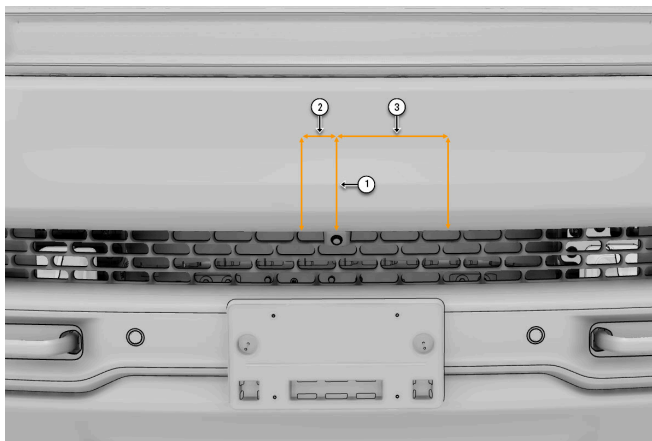
Figure 1. No-Repair Zone

Rivian passenger vehicles are equipped with radar sensors located behind the front bumper fascia. To avoid interference with the Sensor, Radar, Front, Center and the integrated safety systems, repair is not allowed to the Fascia, Front, Upper in front of the component.

In addition to repairs, repainting (primers, sealers, and base coats) is not allowed in the No-Repair Zone. Only clearcoat can be applied in the No-Repair Zone. If any repair beyond clearcoat application is required in the radar transmission area, the bumper must be replaced. Repairs outside the No-Repair Zone area are allowed.

To locate the Sensor, Radar, Front, Center under the Fascia, Front, Upper, measure up from the Camera, Bumper, Front. Then, measure left and right to create a rectangle; the rectangle represents the radar transmission area and No-Repair Zone.
